Manhole Inspection Summary

Manhole # S13Q__029MH

Insp Date: **3/18/08 12:50 PM**

Location Address: **2804 Wilkens Ave**

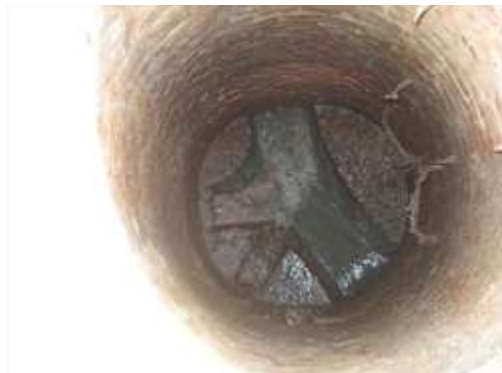
Top View

cover worn

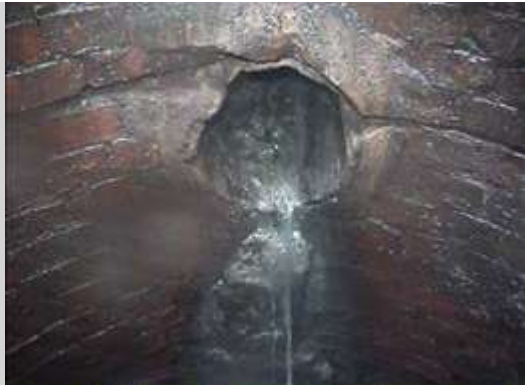
6 O'Clock Inflow

8 in. Circular Gravity Sewer

Pipe In @ 6 O'Clock

Pipe Height: **8.4** (in.) Rod and Bar (Angled)

Pipe Material: **Clay** ☐ Pipe Lined

Infiltration: **None**
